Workplace Health and Safety Queensland

Asbestos flooring

This fact sheet provides information regarding asbestos backed vinyl sheet flooring and vinyl tiles containing asbestos.

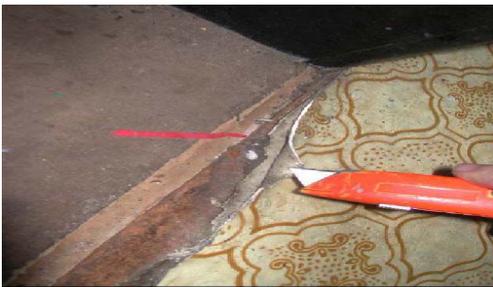
Figure 1 - Asbestos backed vinyl sheet flooring

Asbestos backed vinyl sheet flooring is where the 'backing' (the side attached to the floor—see Figure 1) contains friable (easily broken) asbestos material.

The vinyl sheeting itself does not contain asbestos, however, manufacturers sometimes incorporated a felt-like 'backing' for cushioning purposes. It is this backing which contains asbestos (typically 80–100 per cent).

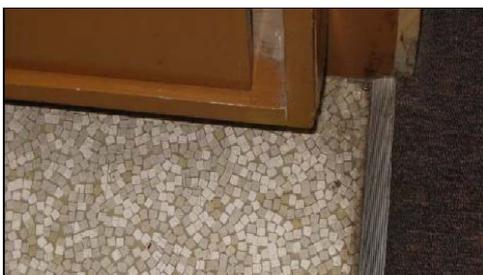
Figure 2 – Terrazzo type asbestos backed vinyl sheet flooring.

Usually applied in sheet form, a lot of asbestos backed vinyl sheet flooring had a 'terrazzo' type (colourful marble or stone chip – see Figure 2) pattern look on the surface. It is most commonly found in buildings constructed before the mid-1980s.

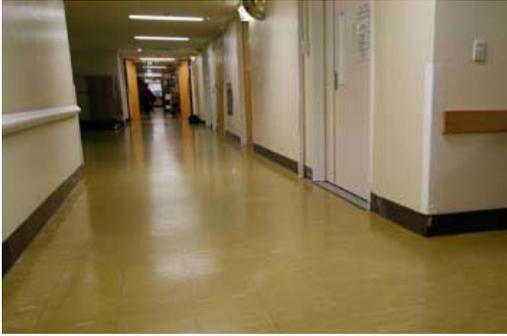
Figure 3 – Asbestos vinyl tiles © Worksafe Victoria

Asbestos vinyl tiles contain 8–30 per cent asbestos in a tightly bonded matrix (see Figure 3). They do not have a 'backing' and are usually glued directly to the floor. It should be noted that glue used to adhere the asbestos vinyl tiles to the floor may also contain asbestos.
